ERDC/GSL TR-03-7

Enhanced Coastal Trafficability: Road Construction Over Sandy Soils

July 2003

Final report

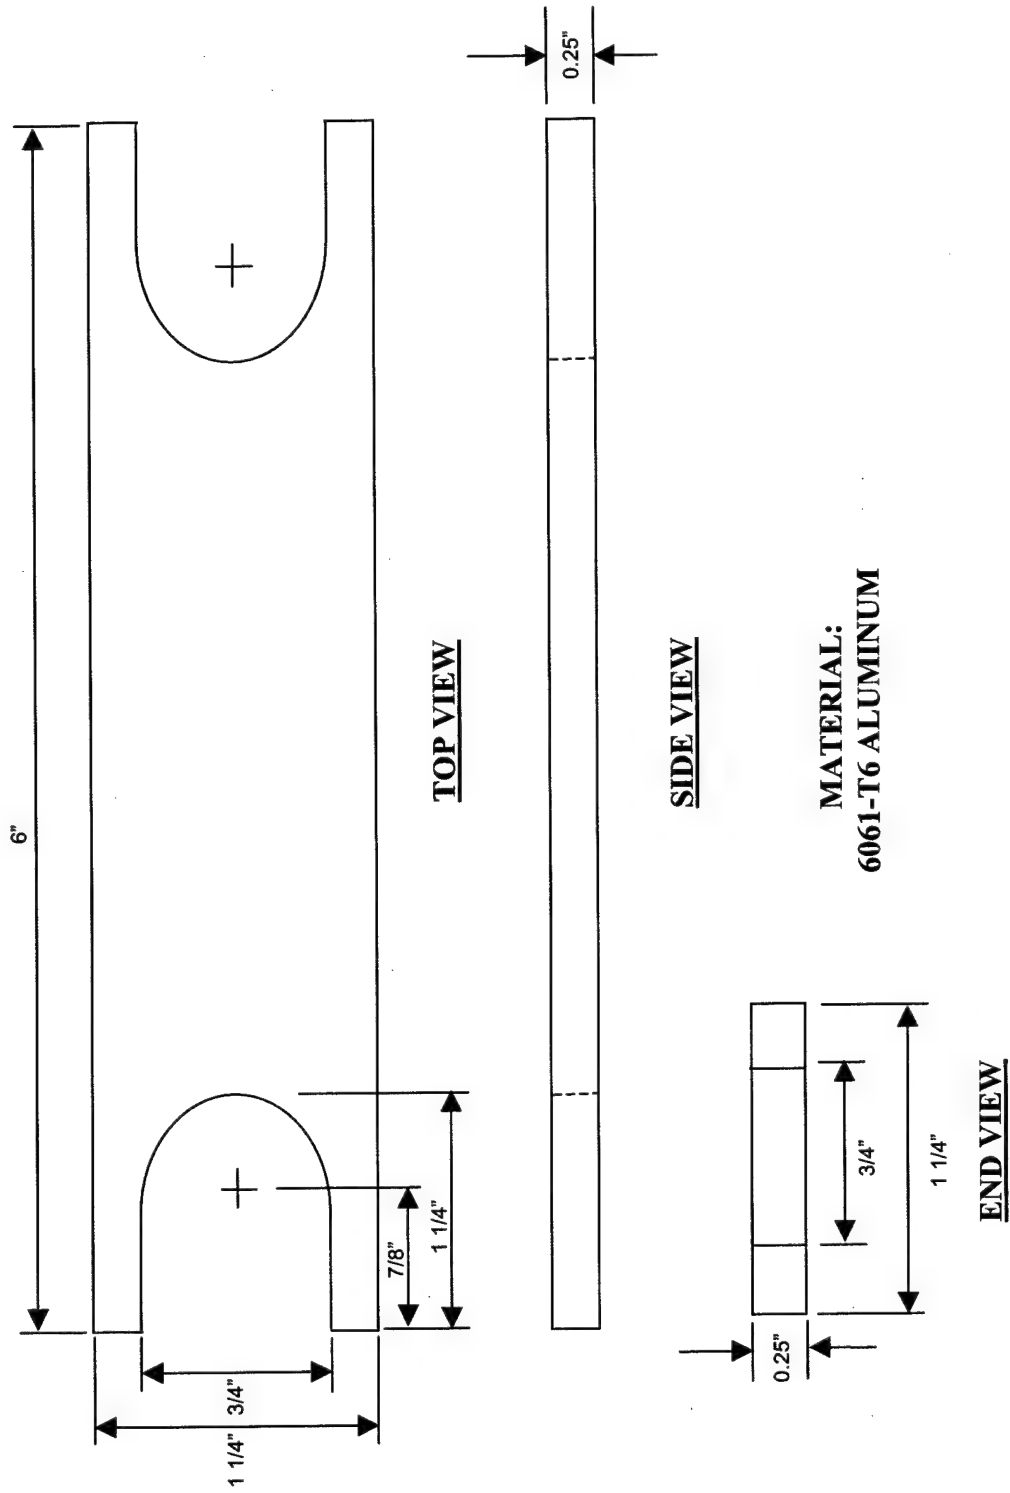
Figure 17. Spacer guide dimensions

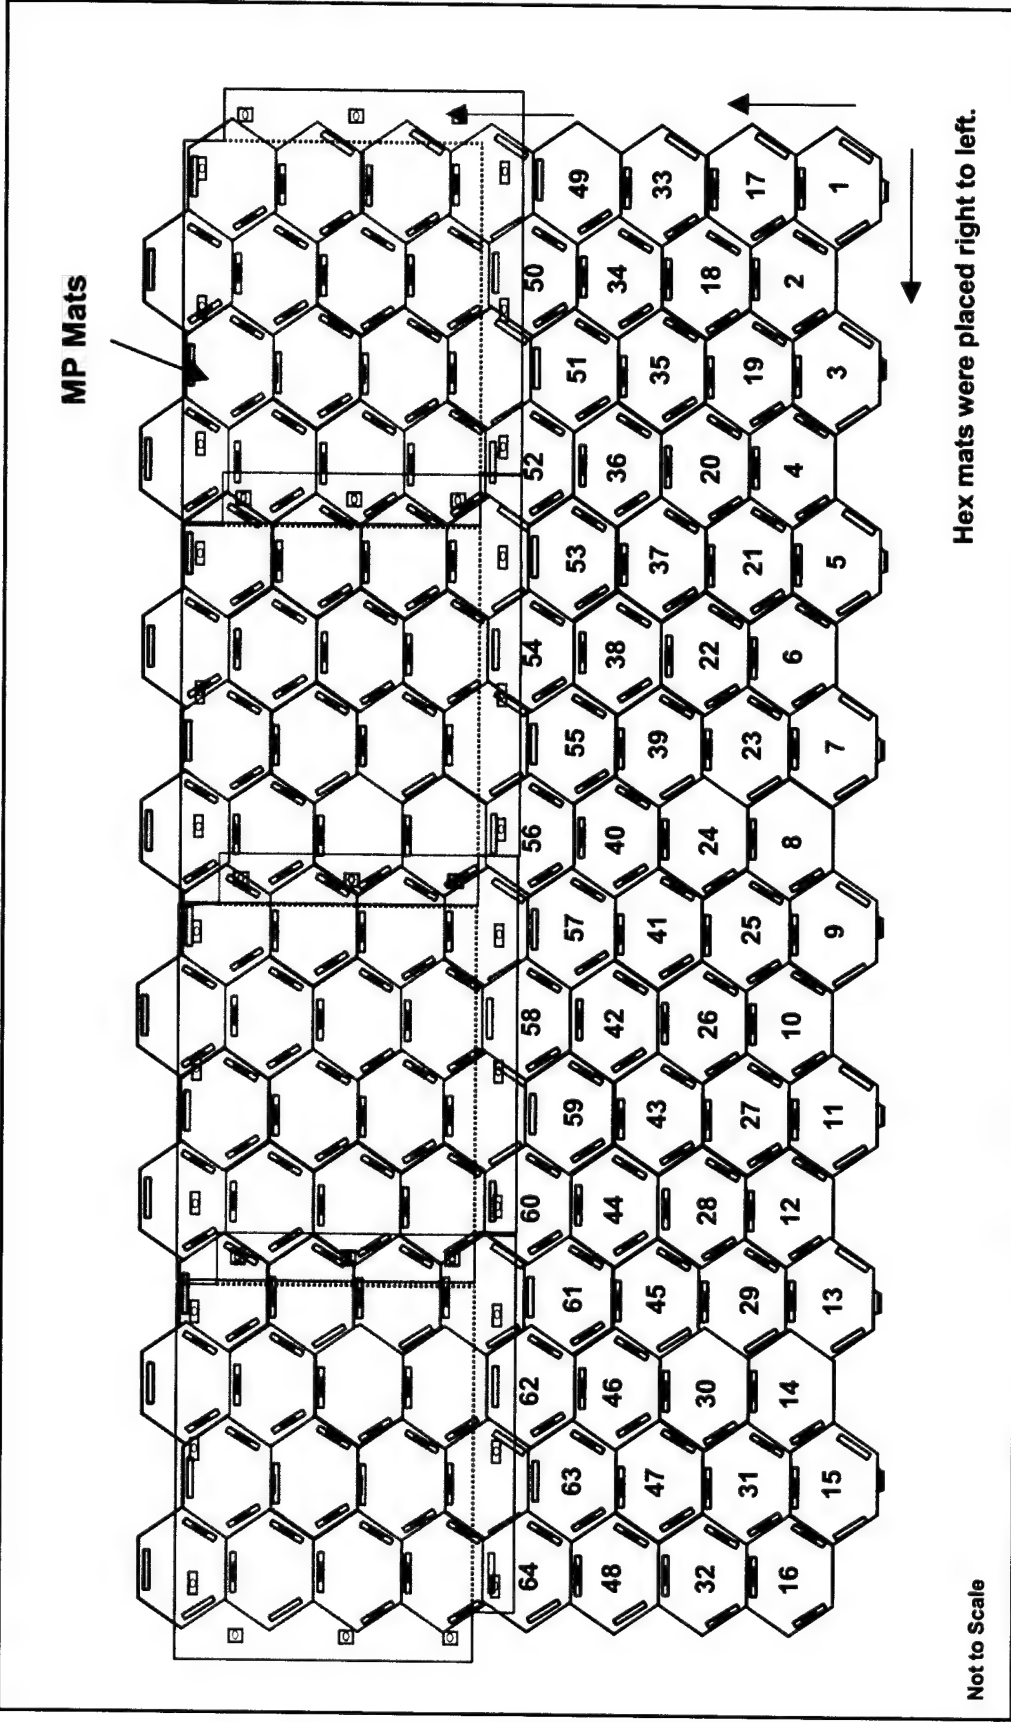
Figure 20. Placement pattern for Allround hexagonal plastic mat

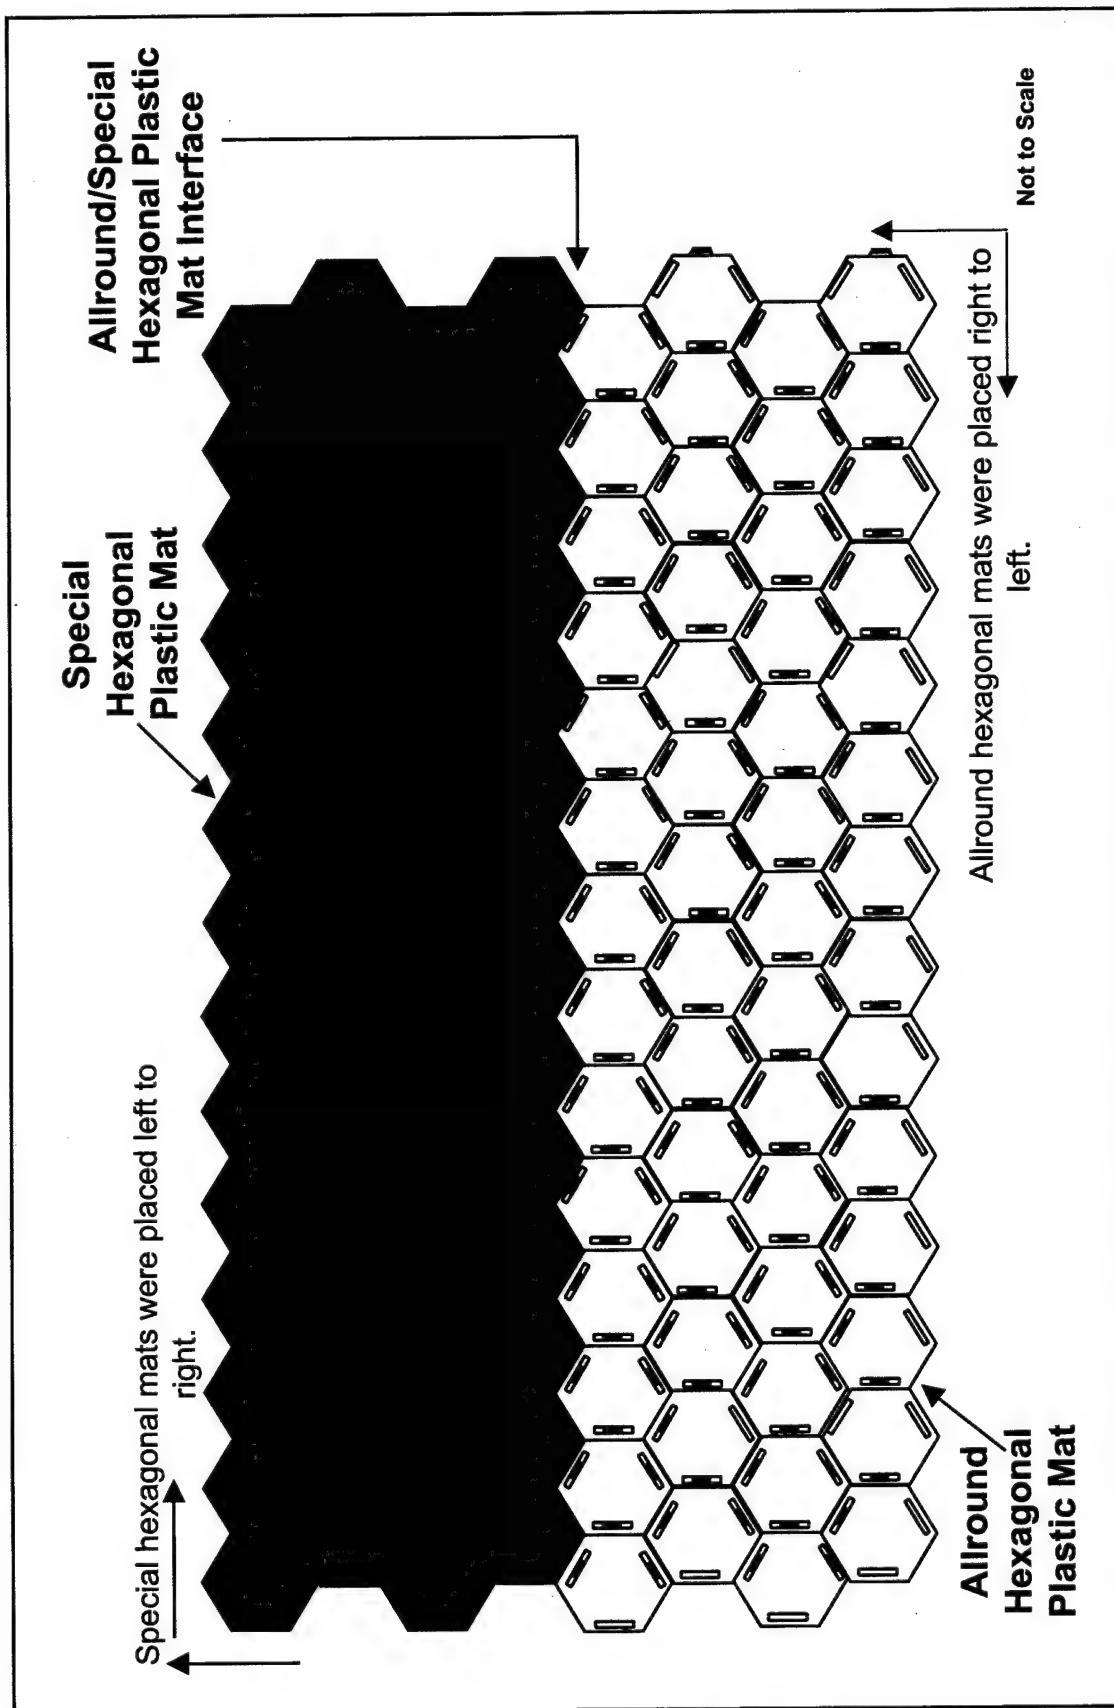
Figure 21. Placement pattern for Special hexagonal plastic mat and transition zone between mats

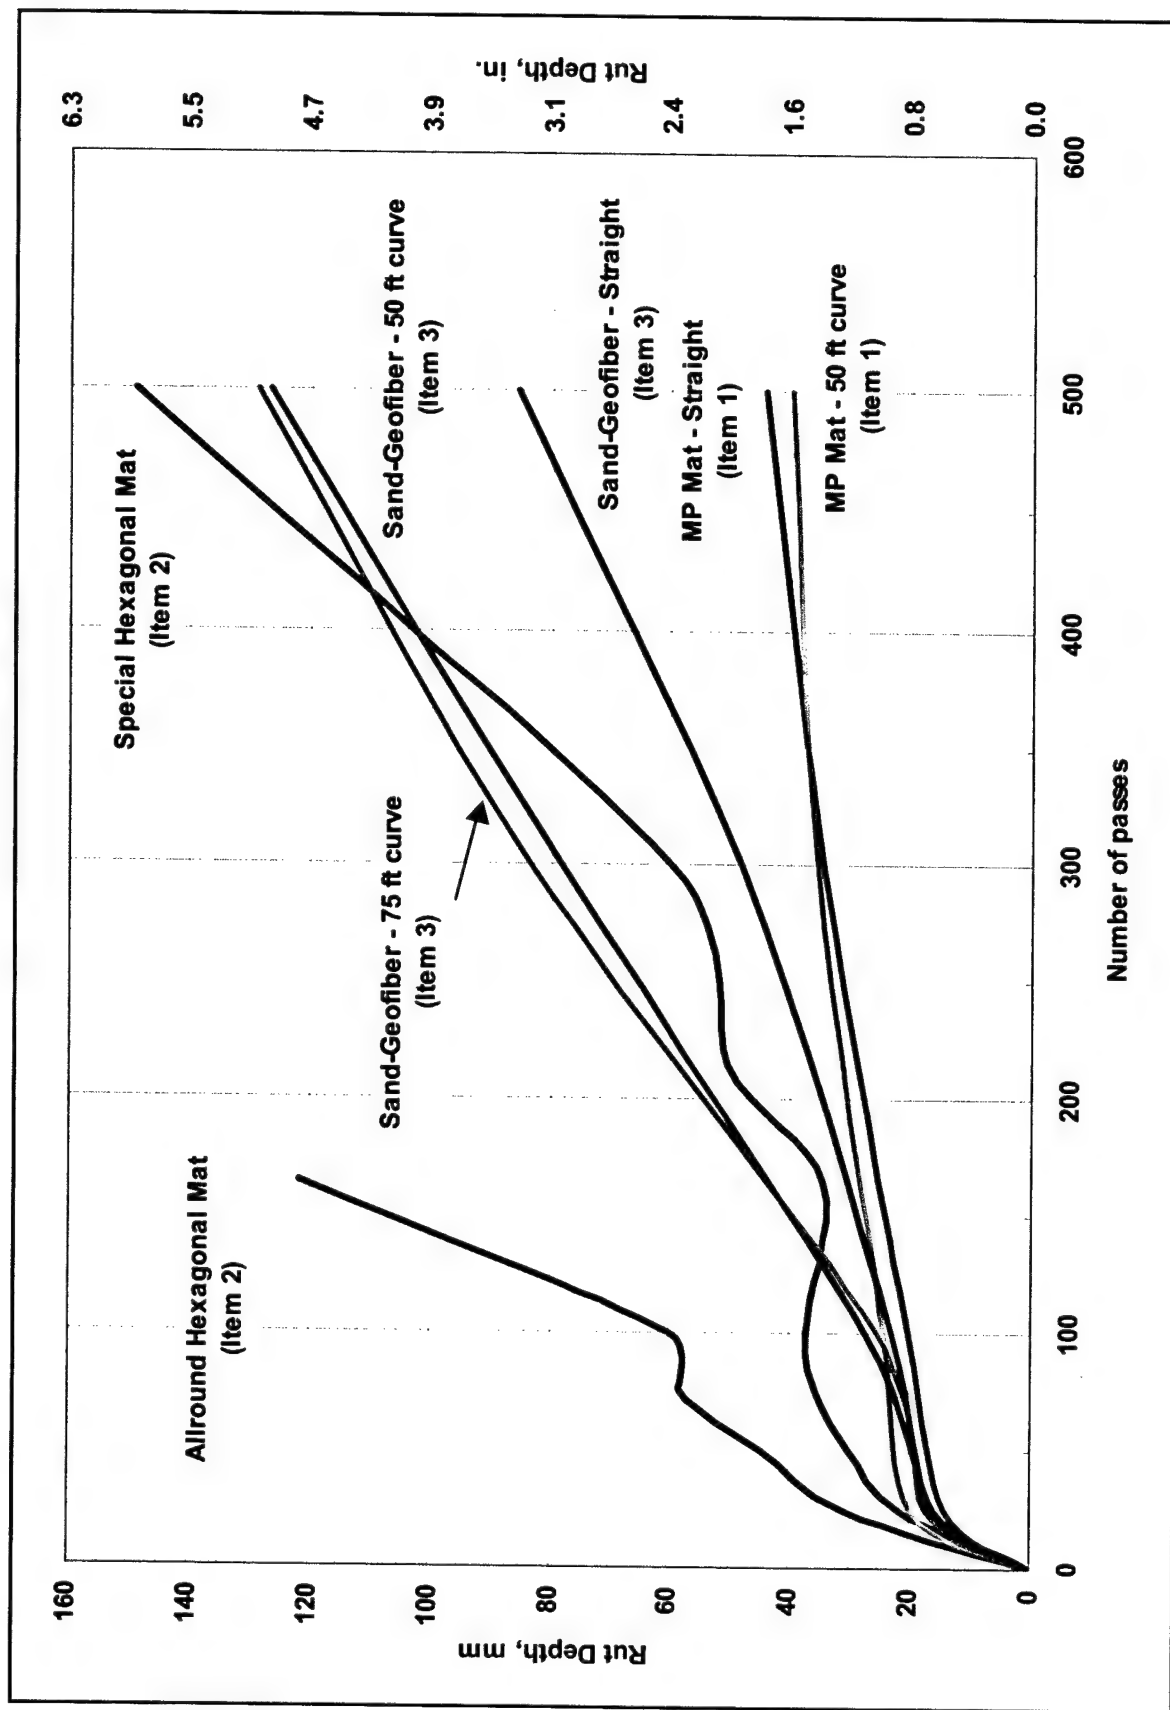
Figure 22. Rut depth measurement for Items 1 to 3

the entire item. The cross section data were normalized (each subsequent measurement was subtracted from baseline data taken at zero passes) to clearly identify the damage due to the applied traffic. Figure 22 presents the average rut depth measurements for Items 1, 2, and 3 at various traffic levels. Table 5 summarizes the detailed rut depth data.

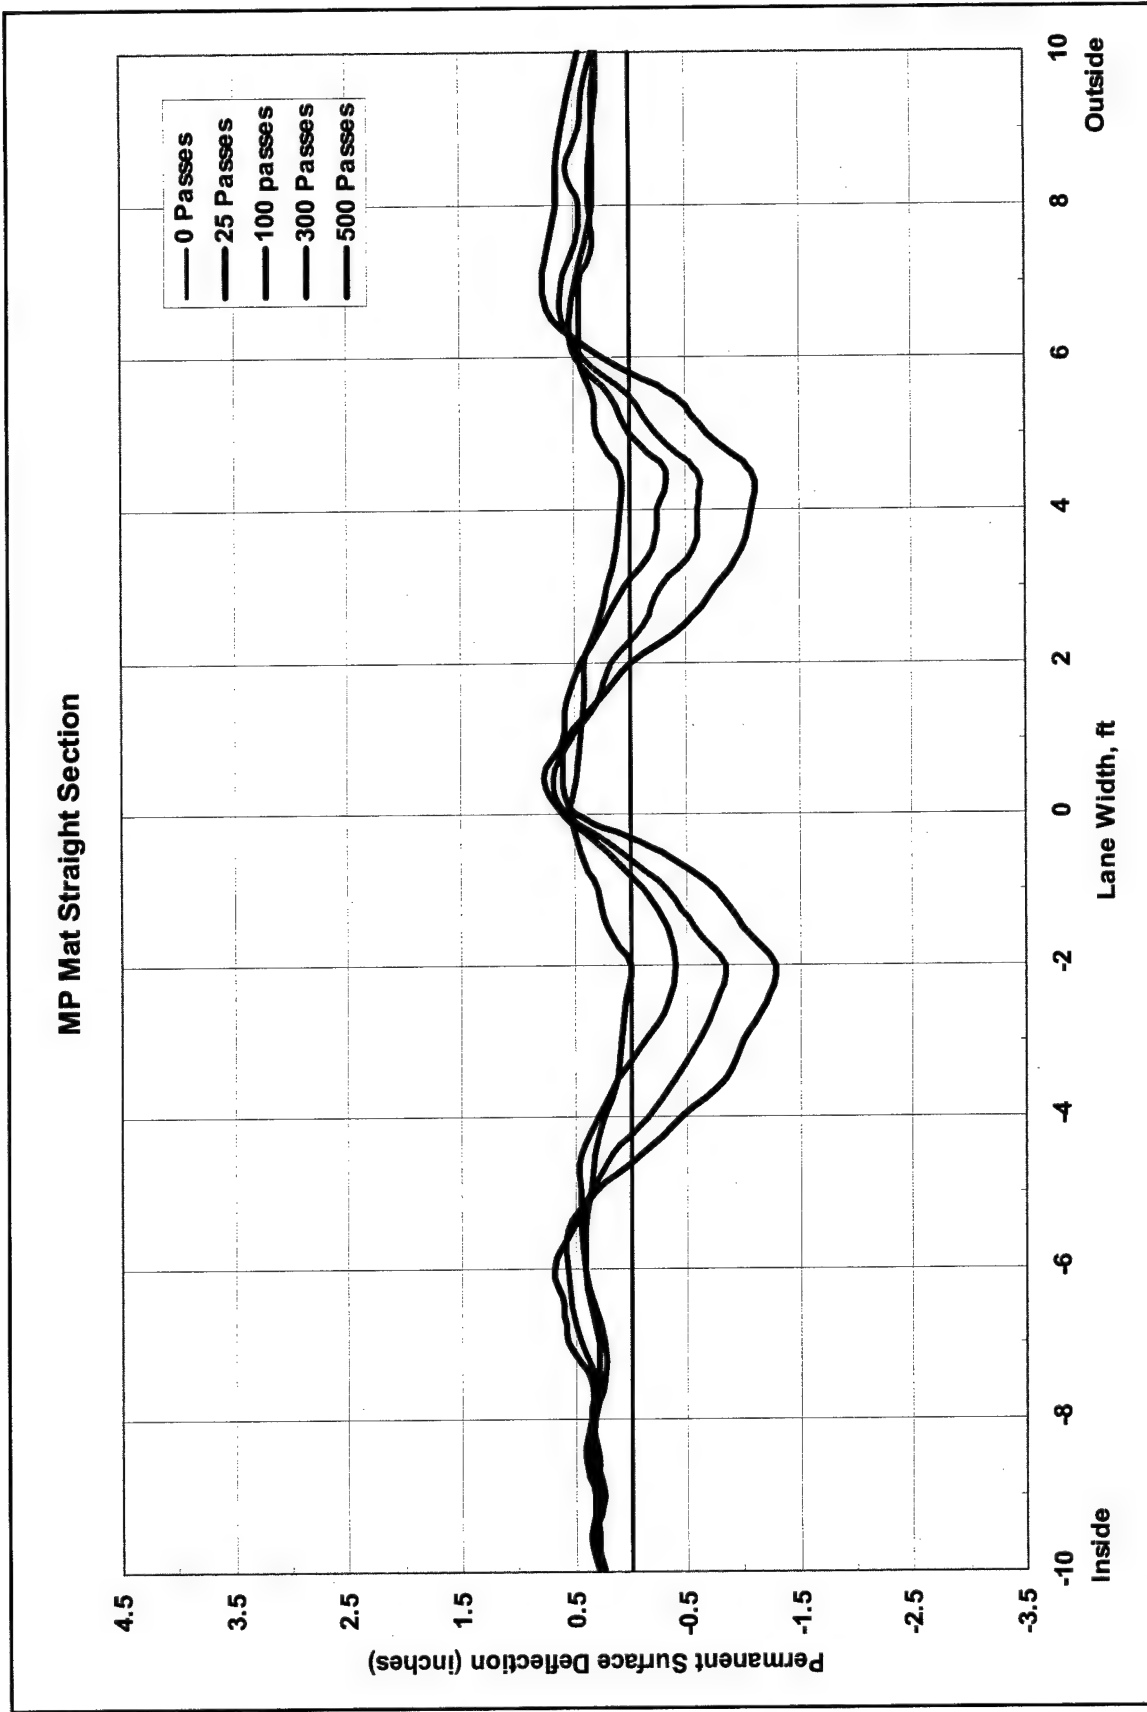
Figure 23. Cross section profile for the MP mat straight section

Straight section. This section reached an average permanent deformation of 1.28 in. after 500 truck passes. The mat and connector pins performed well. One panel was slightly damaged, and one pin was loose. After 300 truck passes, the section moved about 8 in toward traffic direction. Photo 85 shows a total displacement of 12 in. on the straight section after 500 truck passes. One connector pin was not properly tightened and became disconnected after 500 passes (Photo 86). One MP mat delaminated at the downward fold edge as shown Photo 87. The anchor performed well once it locked itself as shown in Photo 88.

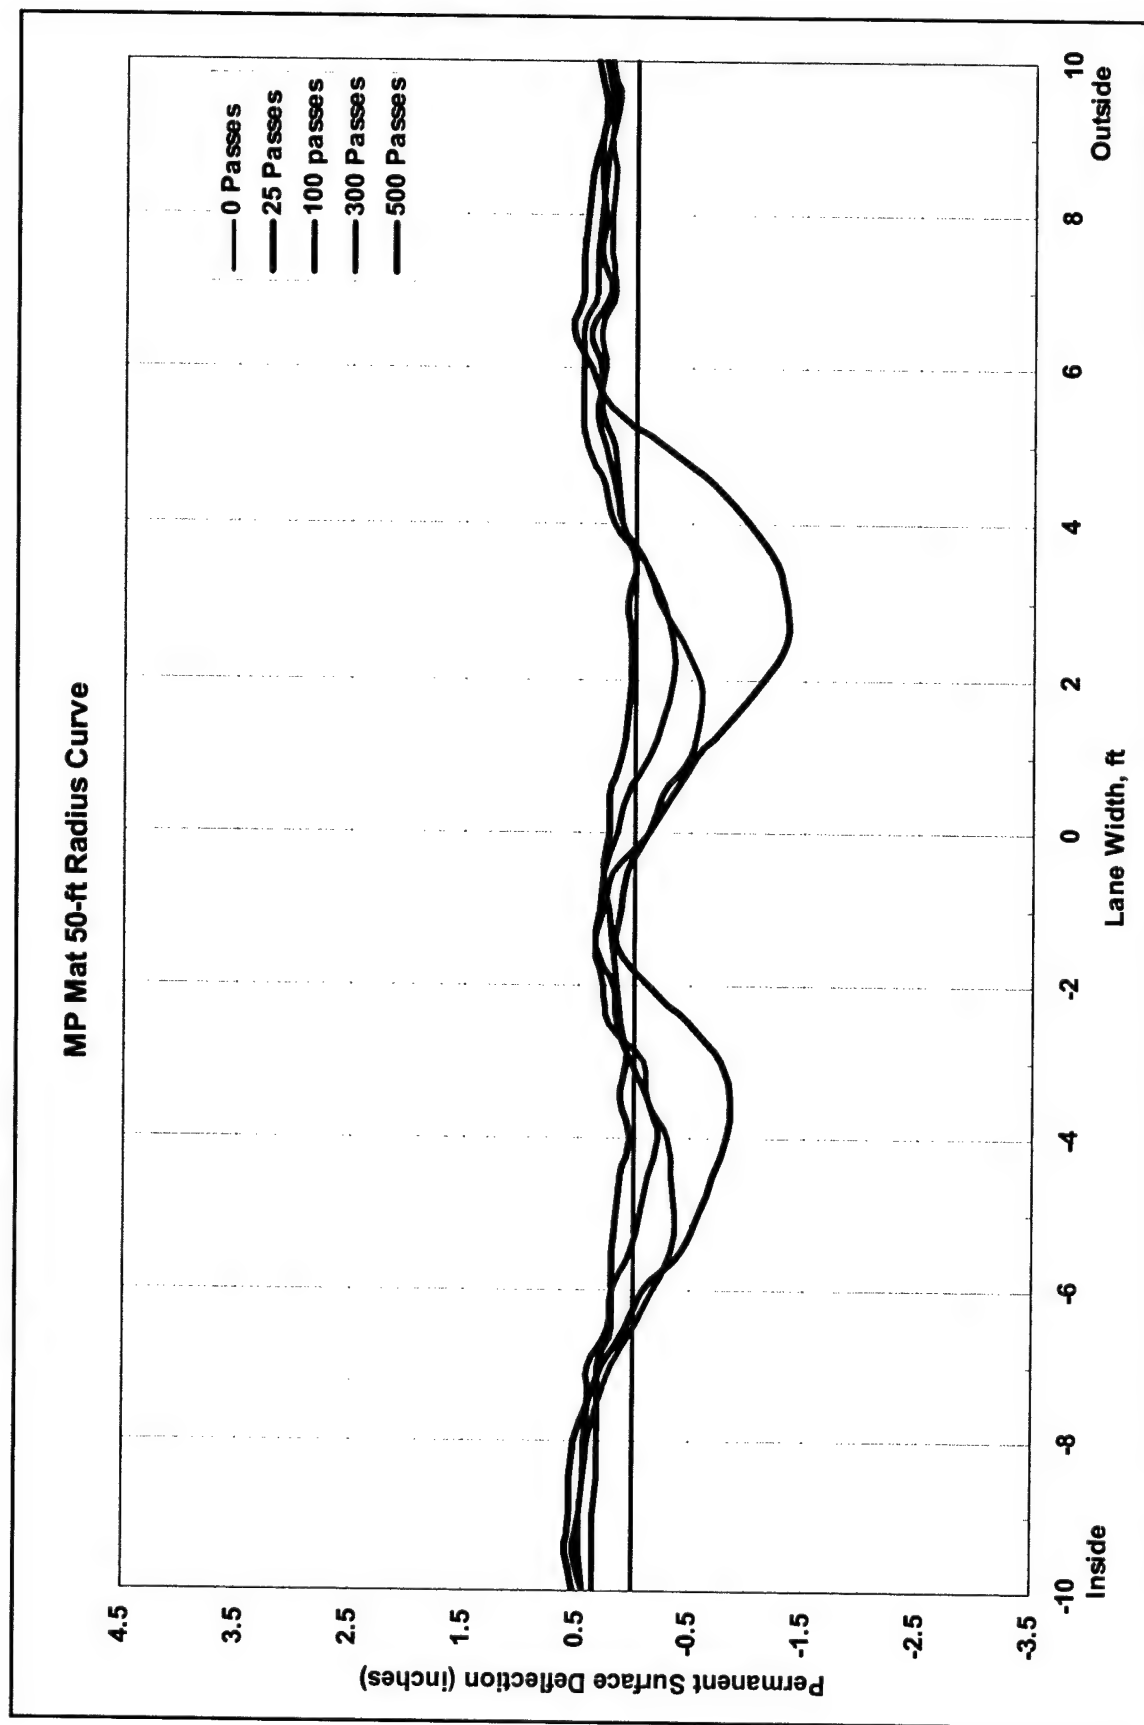
Figure 24. Cross section profile for the MP mat 50-ft radius curved section

1.32 in. after 500 truck passes. The section moved approximately 2 in. laterally after the test traffic (Photo 89). Mats, connector pins, and anchors were in excellent conditions after the 500 passes.

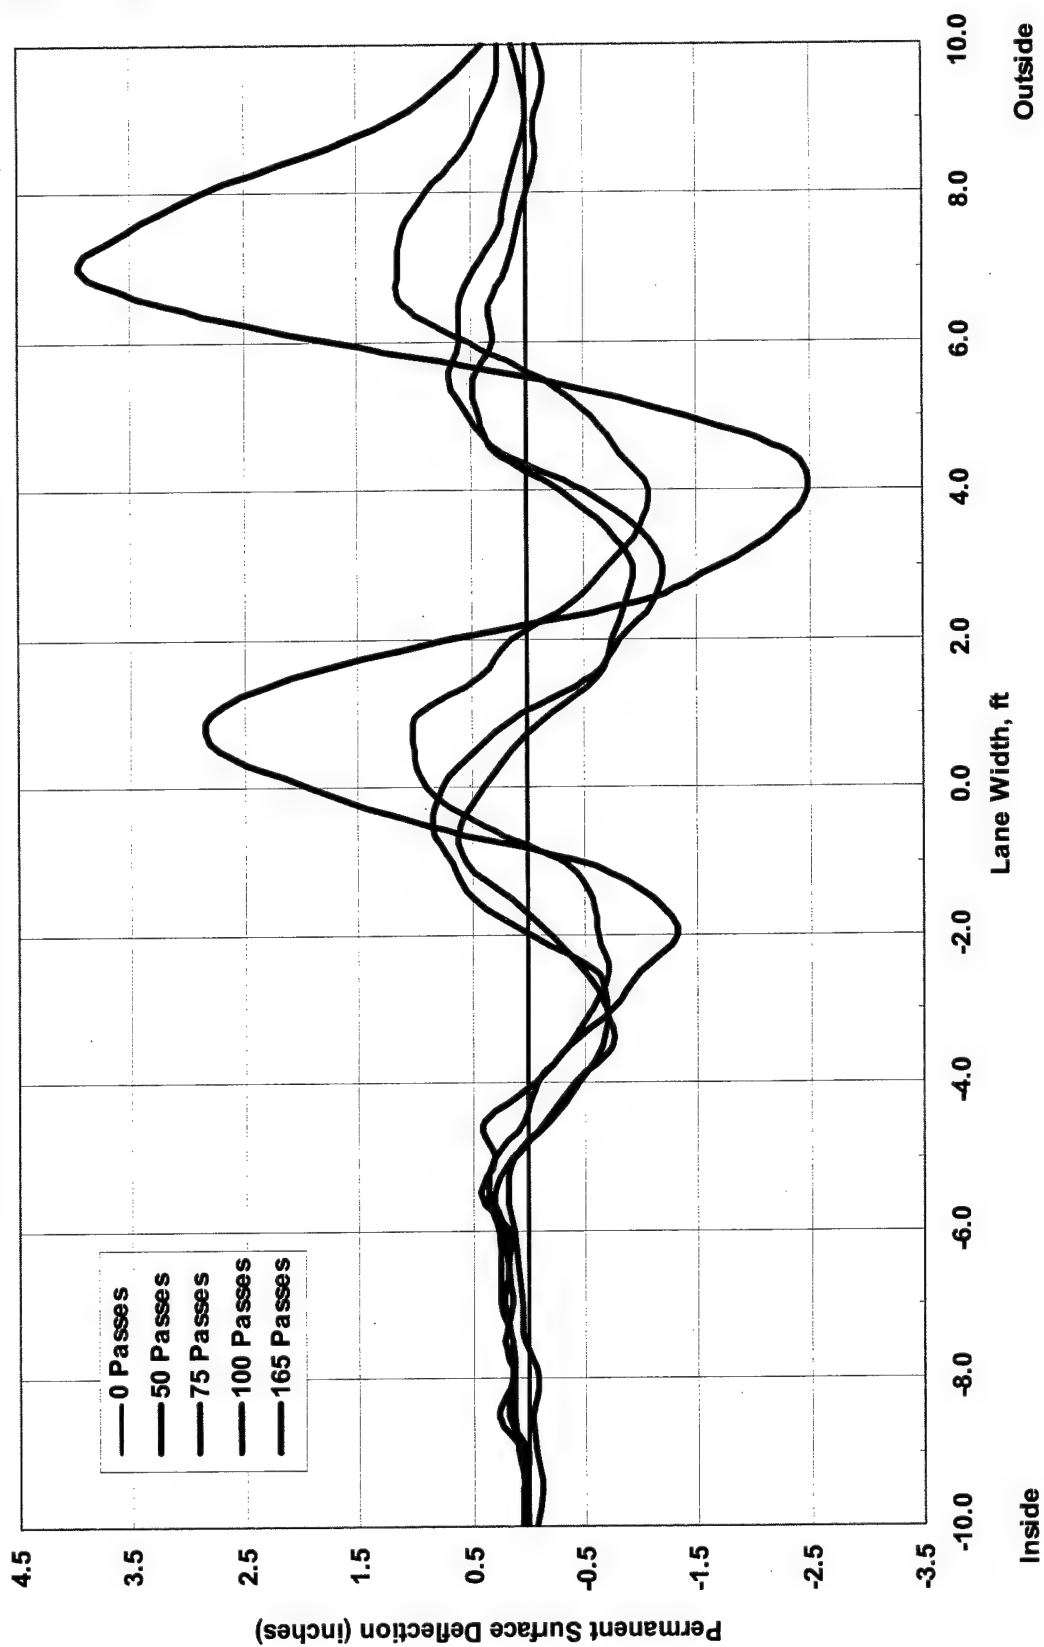
Figure 25. Cross section profile for the Allround hexagonal plastic section

Allround hexagonal plastic mat section. The Allround hexagonal plastic mats section had an outside and inside radius of 74-ft and 50-ft, respectively. These mats were previously tested on straight sections and performed excellent. The performance of this mat under 50-ft radius curves was poor as indicated by 2.49 in. average permanent deformation after 165 truck passes. The maximum permanent deformation was 12 in., therefore, the traffic was discontinued and item was replaced. The mats were removed since the mats were hitting the truck's axles. Forty-two mats were damaged as shown Photos 90 and 91. The mats disconnected at the upheaval and center lane areas. The poor bearing capacity of the loose sand, shear forces caused by truck tires, and poor mat connection mechanisms unzipped the mats in these areas (Photo 92). To maintain trafficability of the field test section, the Allround hexagonal mat section was replaced with a 6 in. layer of crushed limestone.

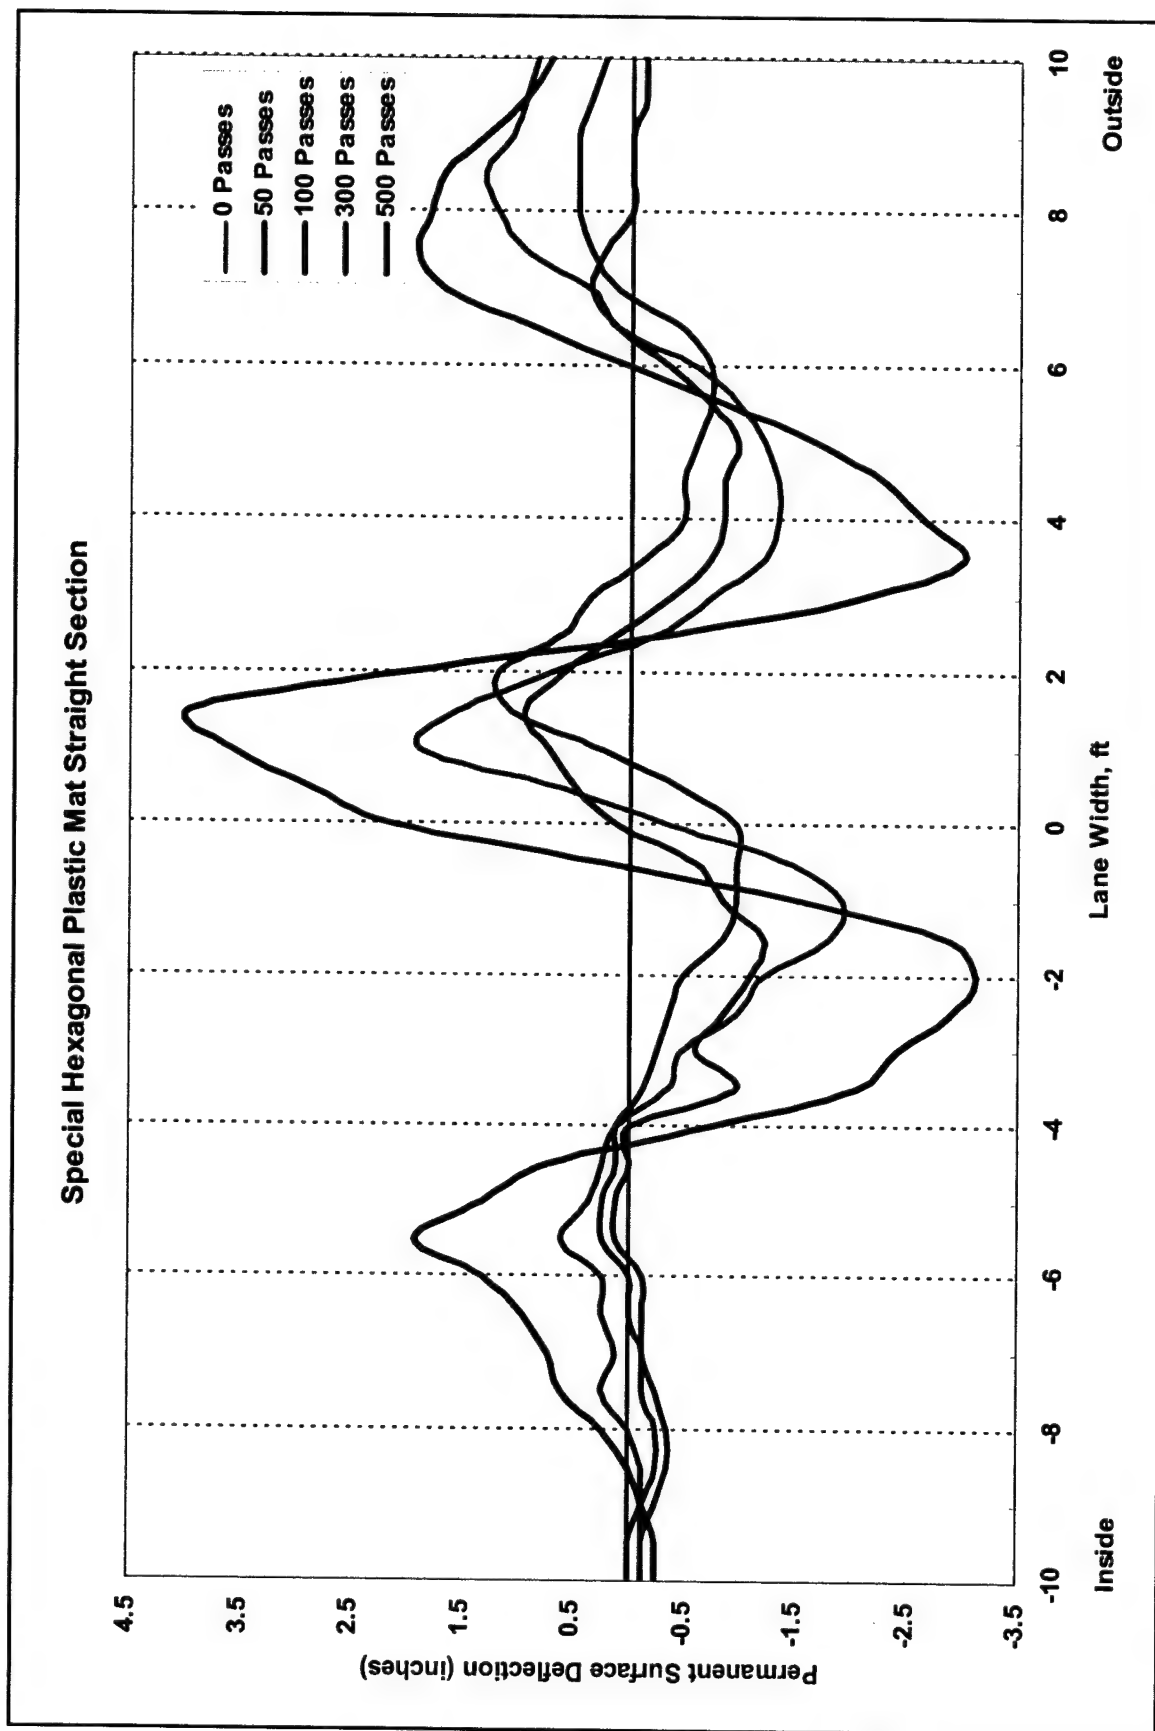
Figure 26. Cross section profile for the Special hexagonal plastic section

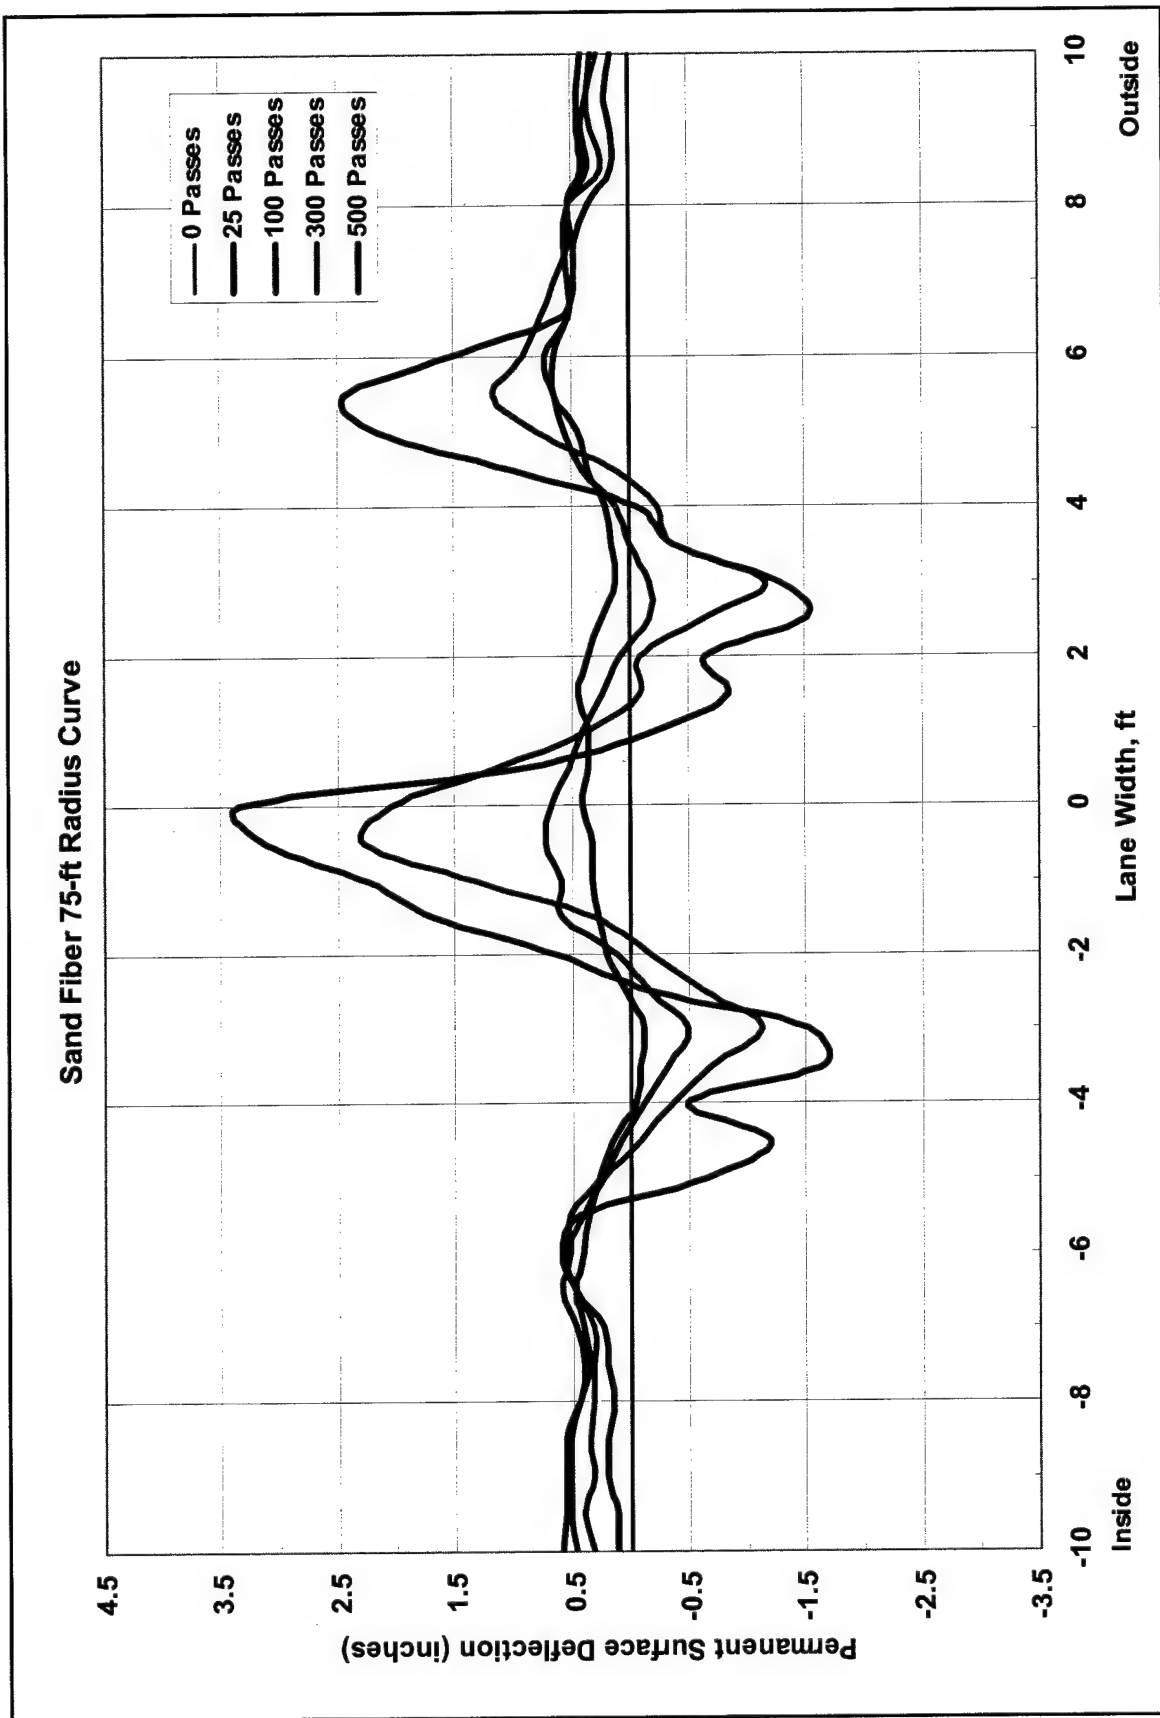
Figure 27. Cross section profile for the sand-geofiber 75-ft radius curved section

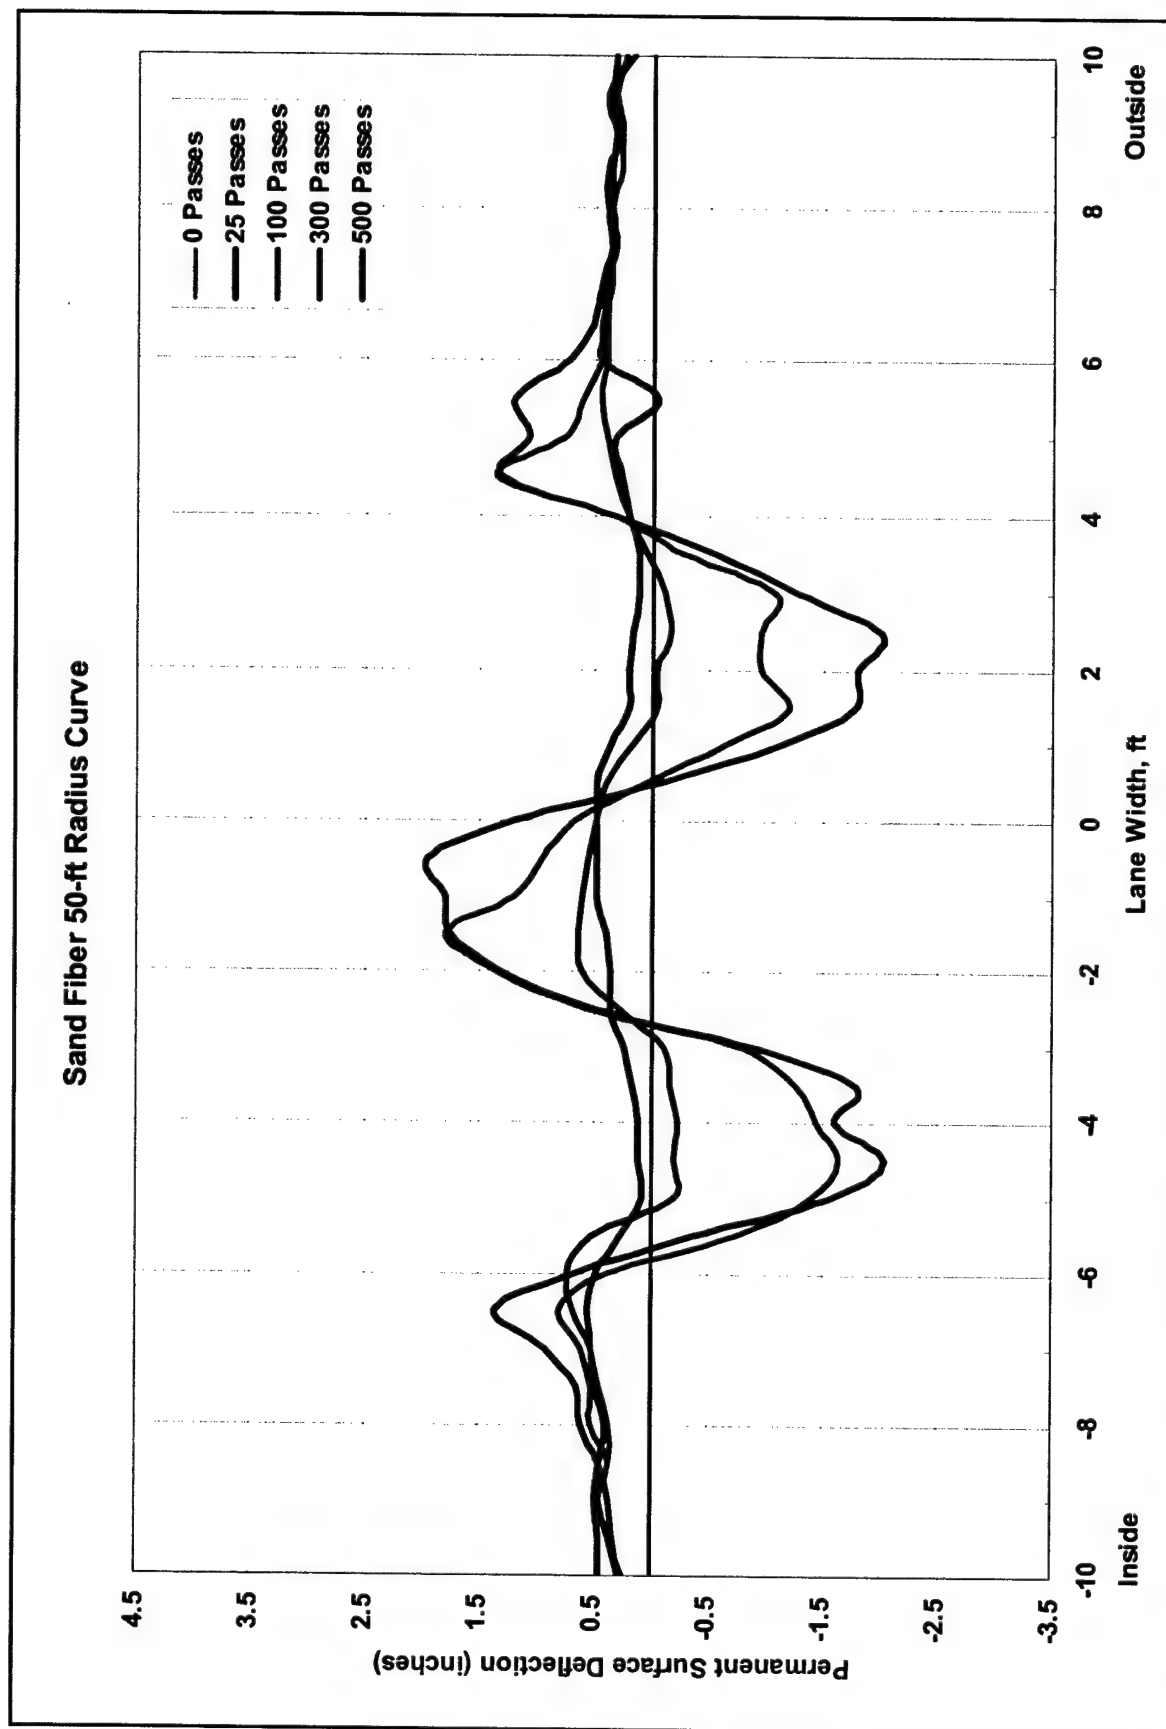
Figure 28. Cross section profile for the sand-geofiber 50-ft radius curved section

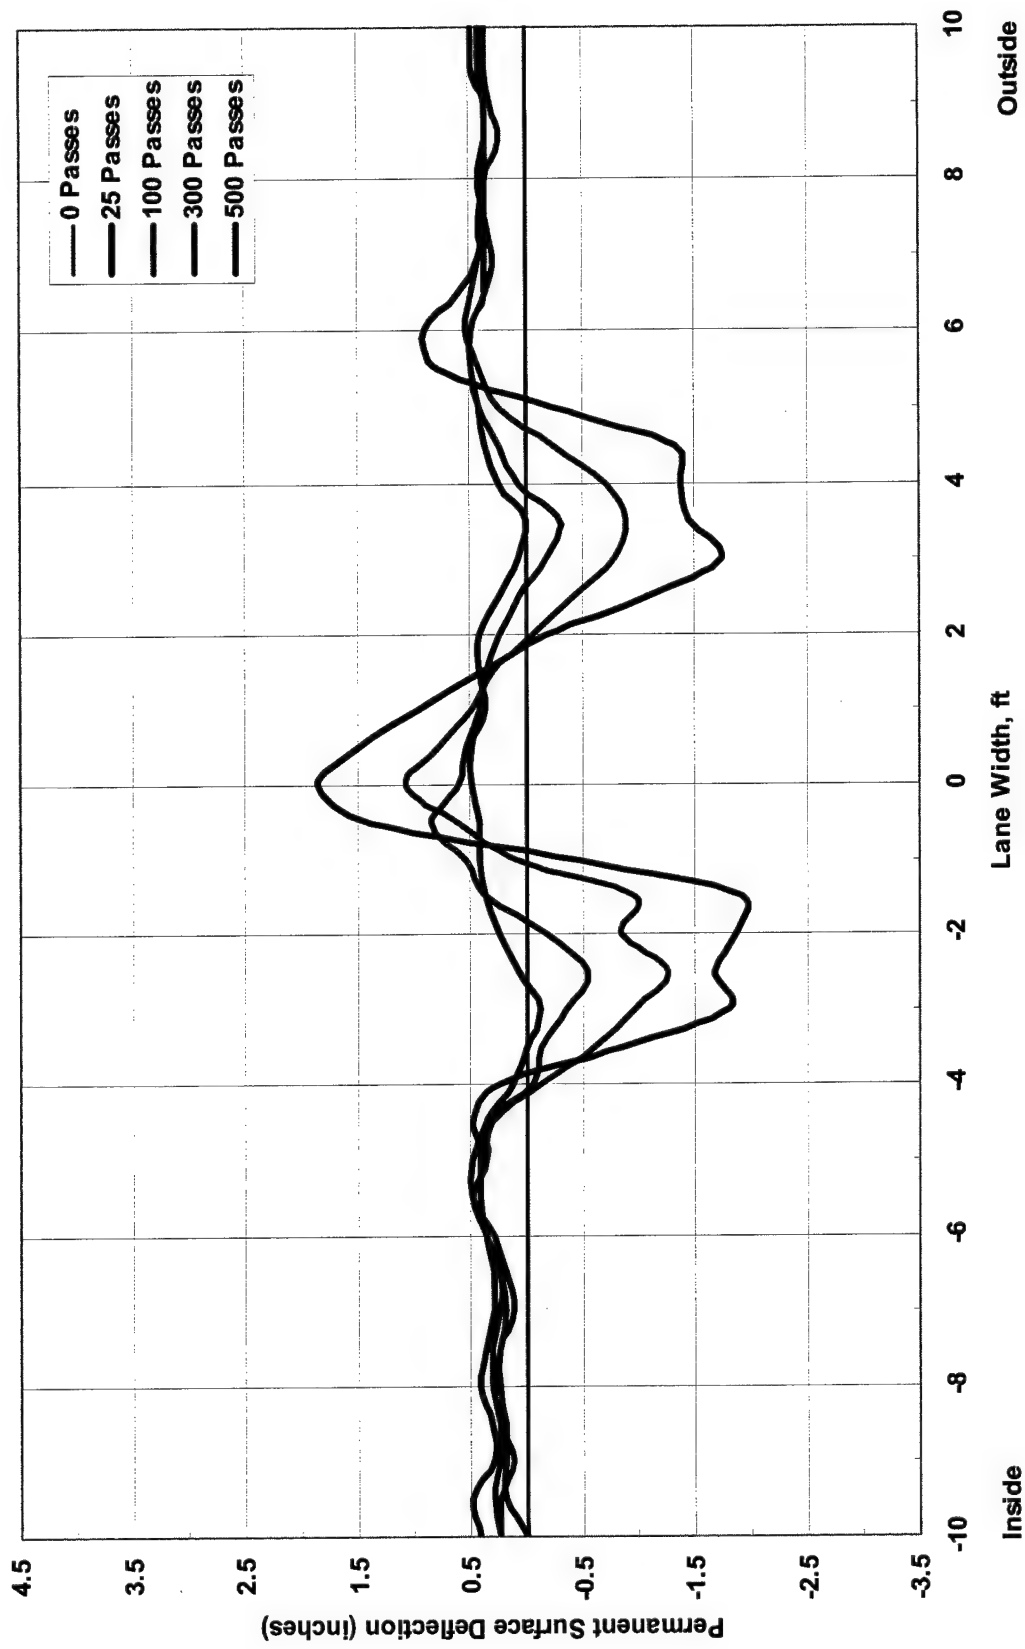
Figure 29. Cross section profile for the sand-geofiber straight section

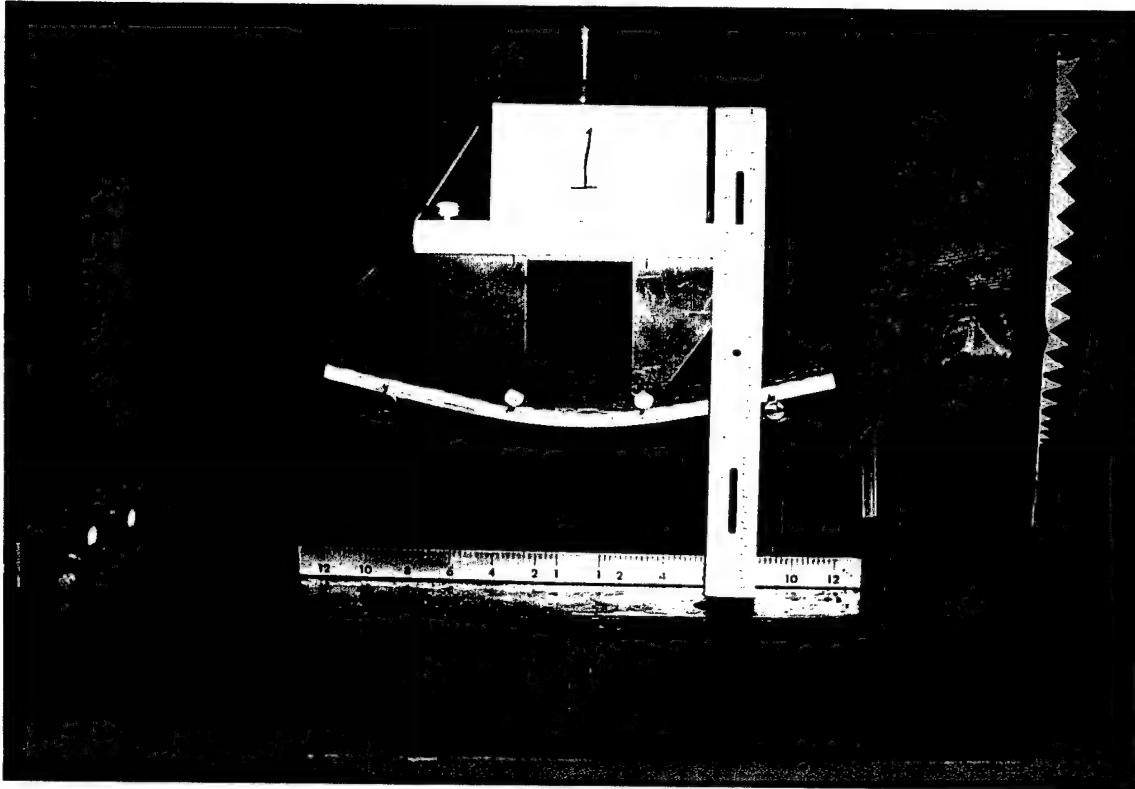
Photo 3. Modified 3-point beam test

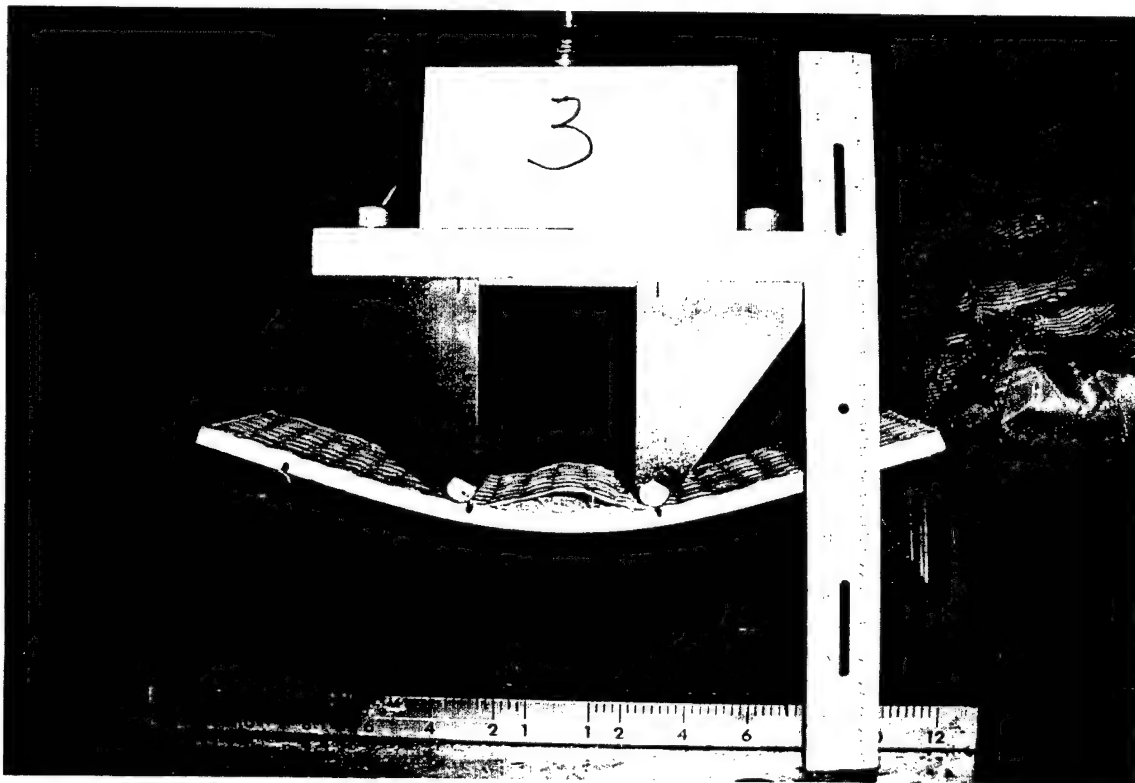
Photo 4. MP mat performance modified 3-point beam test
